Xplornet Tech Tool 1234

Current LTE Open Investigations

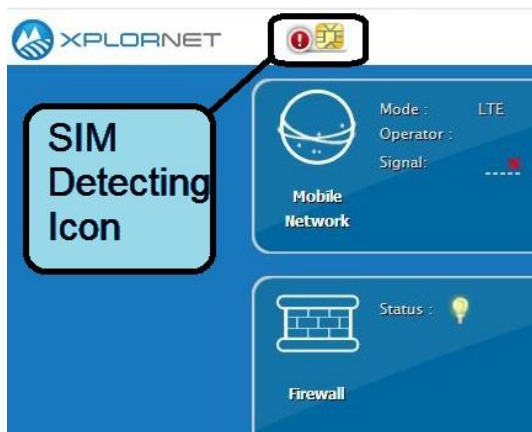
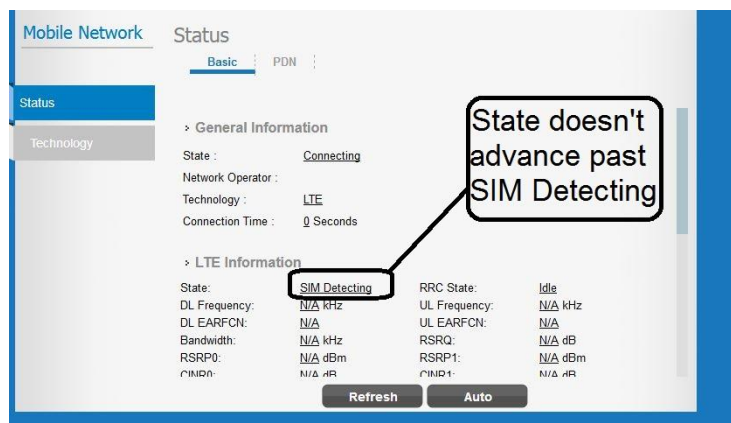
When an LTE CPE first powers up, one of the steps it takes is to confirm there is a valid SIM card inserted. This normally occurs within a few seconds and may happen prior to a user logging in to the Web Management Interface. In the issue currently under investigation, the CPE either reverts to this state after having been operational, or fails to advance past this state when first powered up. In either case, the SIM Detecting icon will be displayed and, on the Mobile Networks page, the LTE State will say “SIM Detecting.” See images below.

If a Category 6 CPE displays these symptoms for more than 30 seconds after powering on, please call Channel Support at 1-866-841-6004. They will record the serial number and IMSI of the device. You may be issued an RMA, or the Channel Support Specialist may ask you to apply a particular firmware update for testing.

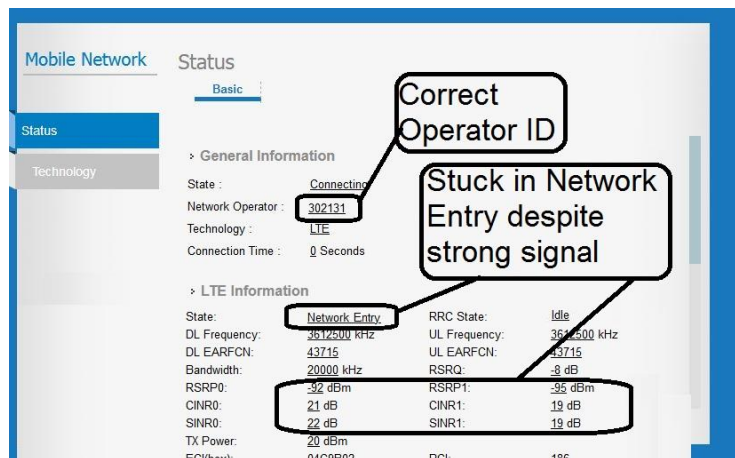
Like SIM Detecting, Network Entry is a normal step in the process of an LTE CPE coming online. However, there are times when a CPE becomes stuck in Network Entry, or will cycle between Network Entry and another state such as Scanning. The issue arises when the CPE is unable to make it past Network Entry and reach an Attached state, despite registering good signal from an in-range Xplornet Access Point (AP). If you encounter this issue, make note of the following and contact Channel Support:

- RSRP and CINR: If these are within normal parameters, the CPE should be able to attach to the network.
- The Operator ID: Any Xplornet AP should broadcast an Operator ID of 302131.
- The ECI (Hex): This is the unique identifier of a given Access Point. Make note of this value when contacting Channel Support.
- The Transmit (TX) Power: This may vary, but a trend in reported cases has been TX Power consistently showing 23dBm.

While other factors may cause a CPE to stay in Network Entry, report all instances to Channel Support with the above information. They will record details, and may advise you to install another CPE, or to install an alternate firmware for troubleshooting or testing purposes.
