Xplornet Tech Tool 1241

CAT6 LTE Firmware

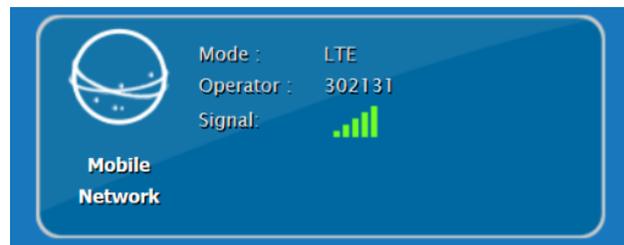
- Step 1** Once logged into the CPE click Mobile Network.

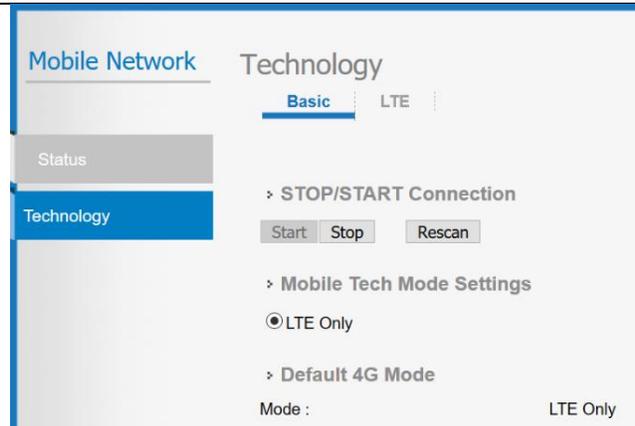
- Step 2** Click Technology.
-

Step 3 Click Rescan as needed.

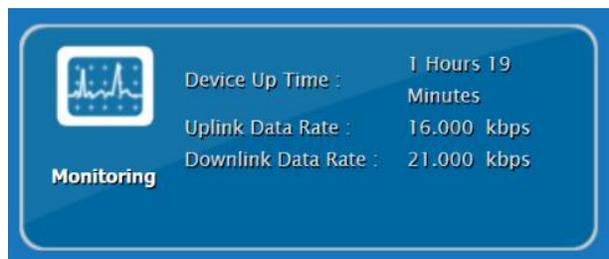
Step 2 Click Monitoring

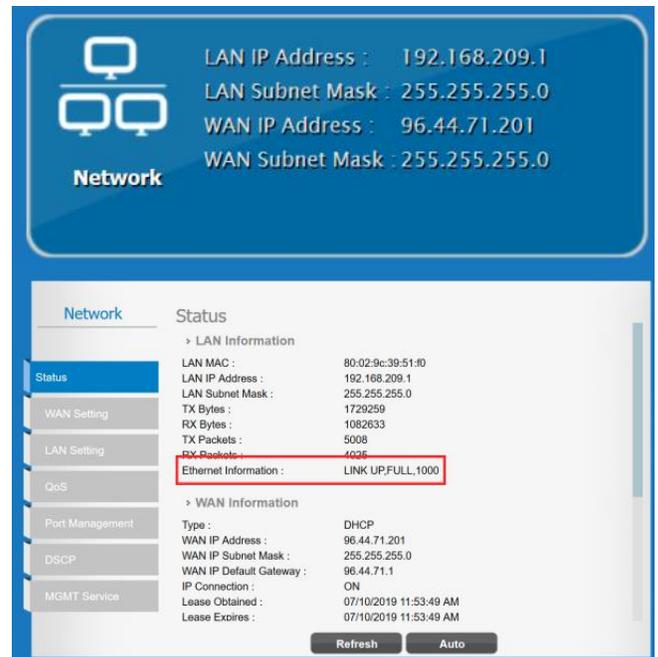
Step 3 At the top under LAN information, look for the Ethernet Information.

You will see 3 parameters

State: LINK UP or LINK DOWN

Duplexing: FULL OR HALF

Speed: 10, 100, 1000

1000: Should always be 1000 wherever possible.

The screenshot shows the Network Status page of a CPE. At the top, there is a 'Network' section with a status icon and the following information:

- LAN IP Address : 192.168.209.1
- LAN Subnet Mask : 255.255.255.0
- WAN IP Address : 96.44.71.201
- WAN Subnet Mask : 255.255.255.0

Below this is a 'Status' section with a sidebar menu on the left containing: Status, WAN Setting, LAN Setting, QoS, Port Management, DSCP, and MGMT Service. The main content area shows:

- LAN Information**
 - LAN MAC : 80:02:9c:39:51:10
 - LAN IP Address : 192.168.209.1
 - LAN Subnet Mask : 255.255.255.0
 - TX Bytes : 1729259
 - RX Bytes : 1082633
 - TX Packets : 5008
 - RX Packets : 4026
 - Ethernet Information : LINK UP,FULL,1000** (highlighted with a red box)
- WAN Information**
 - Type : DHCP
 - WAN IP Address : 96.44.71.201
 - WAN IP Subnet Mask : 255.255.255.0
 - WAN IP Default Gateway : 96.44.71.1
 - IP Connection : ON
 - Lease Obtained : 07/10/2019 11:53:49 AM
 - Lease Expires : 07/10/2019 11:53:49 AM

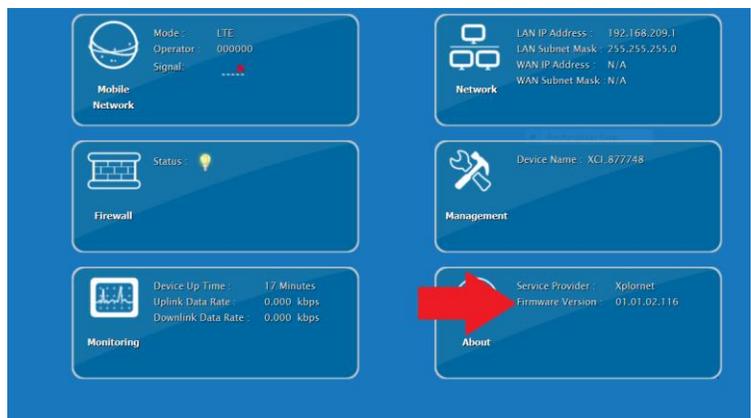
The landing screen appears, with the current firmware version visible on the About tile:

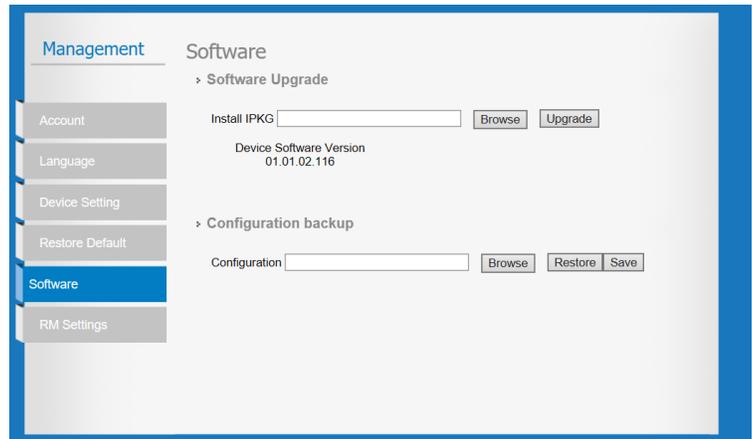
Step 3 In the **Install IPKG** section at the top of the page, click Browse and select the applicable firmware.

The file name is **FW-XCI_01.01.02.151.ipk**

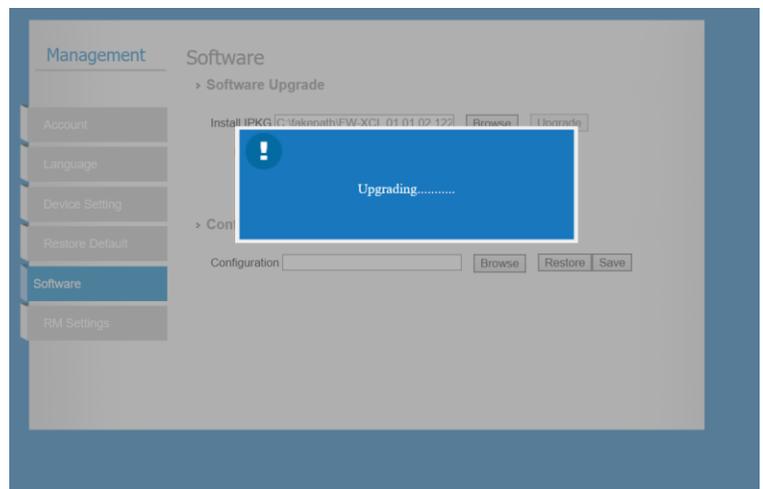
Step 4 Click Upgrade. You will see a screen that indicates the upgrade is being applied. Wait for the upgrade to finish (will take ~2 minutes) and then the CPE automatically reboots.

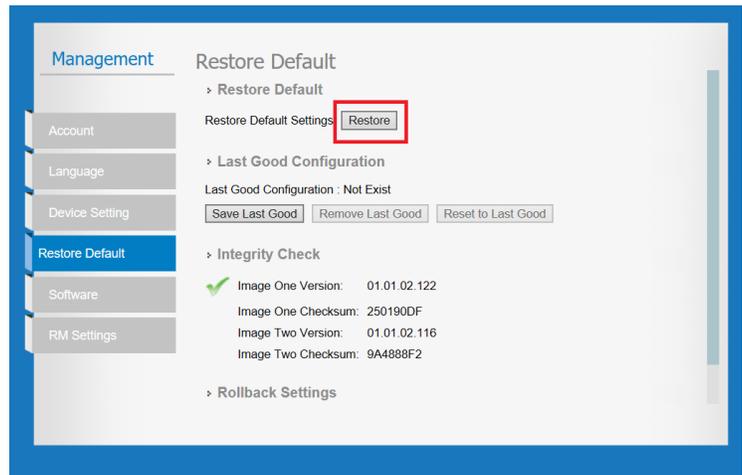
Step 1 After logging back in to the CPE, browse to the Management menu again. This time, click the option called Restore Default on the left-hand menu.

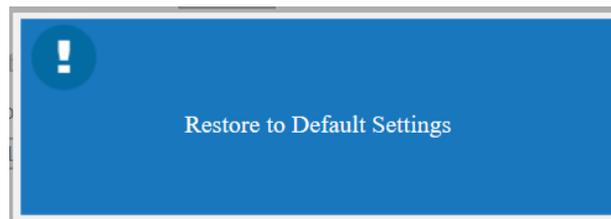
Step 2 Click Restore. A dialog appears confirming you wish to restore to factory defaults. Click Yes. A status message will appear indicating the device is being restored.

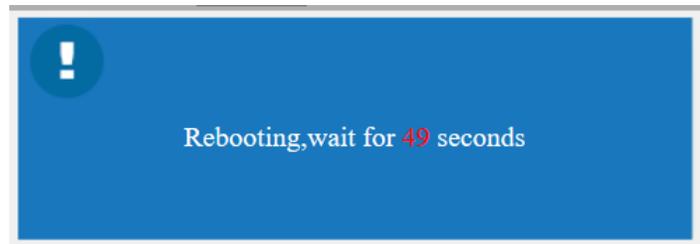
Step 3 The CPE will then automatically reboot, displaying a timer just as it did after the firmware upgrade.
